Unlined Reusable Filament Wound Composite Cryogenic Tank Testing

A.W. Murphy, R.E. Lake, and C. Wilkerson

Marshall Space Flight Center, Marshall Space Flight Center, Alabama

UNLINED REUSABLE FILAMENT WOUND COMPOSITE CRYOGENIC TANK TESTING

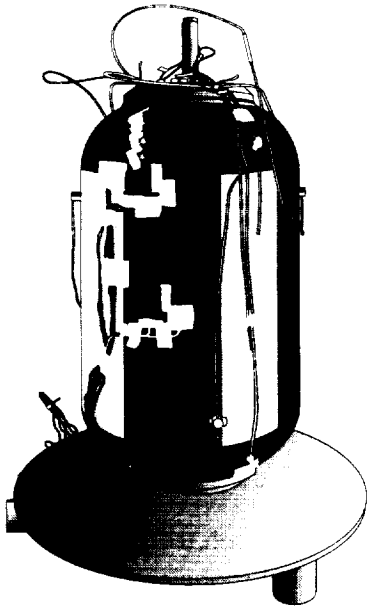
Figure 1. Composite tank configured for testing.

The test article was instrumented by MSFC with 15 strain gauges, four acoustic transducers, and four thermocouples, all located on the outer skin of the tank (see fig. 1). The thermocouples, which indicated the skin temperature, were mounted in four locations: on the bottom dome, 6 inches higher on the barrel, 6 inches higher on the barrel, and on the upper dome.

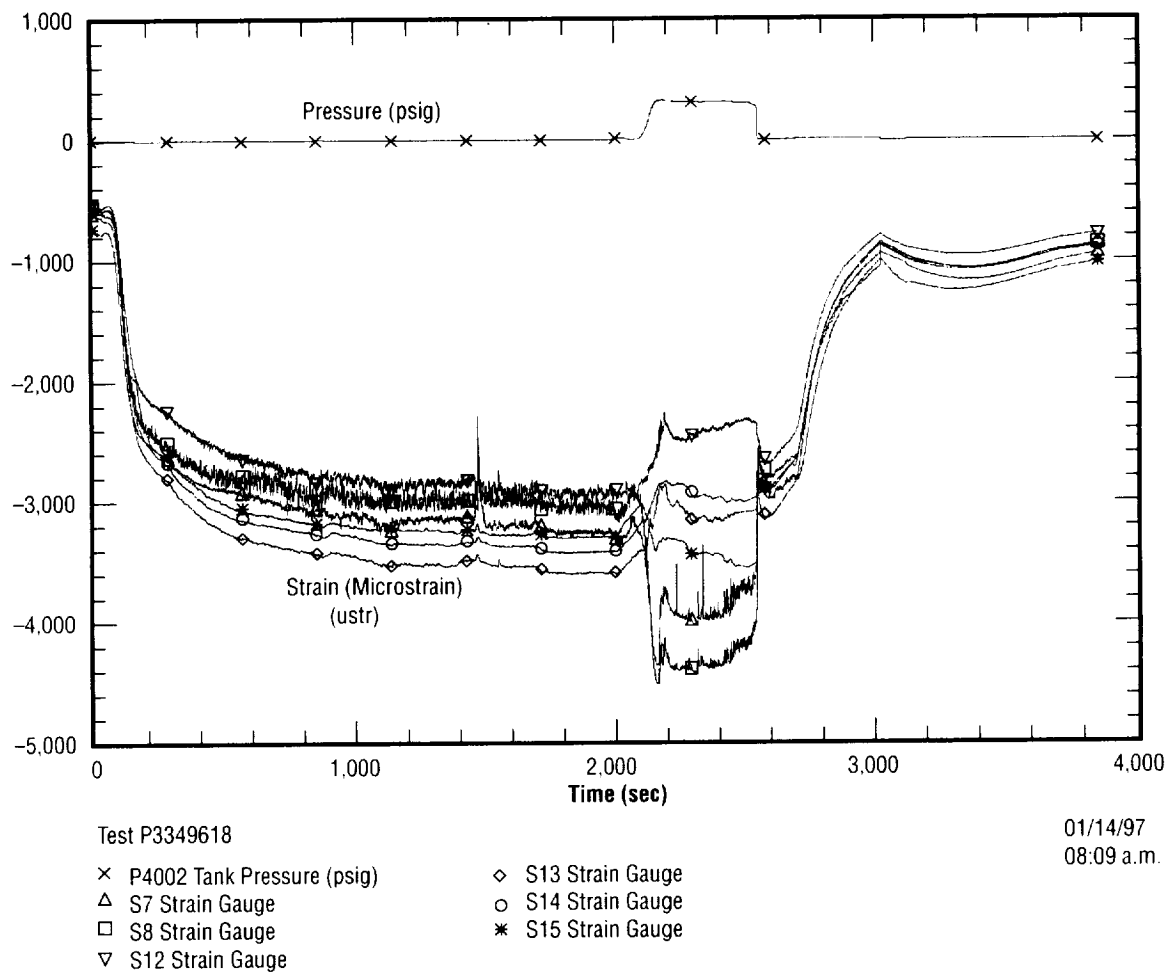
Figure 3. Representative strain gauge output.

During the test, the compensating gauges did not adhere adequately to the tank surface. Therefore, the compensating gauges were not at the same temperature as the measuring gauges. This resulted in the apparent strain not being subtracted from the signal. Consequently, all of the strain readings were of little value since they were a combination of the actual strain, apparent strain of the measuring gauge, and the apparent strain of the compensating gauge. A typical output of the strain gauges is shown in figure 3. Post-test inspection showed that the measuring gauges bonded well to the tank surface. The compensating gauges were peeled off the tank surface by the waterproof coating. The air gaps under the gauge and the tape prevented the waterproof coating from adhering to the tank surface after repeated thermal cycles.
